Analysis of Starship booster design and its evolution over 2.5 years of flight testing

Yu. I. Lobanovsky

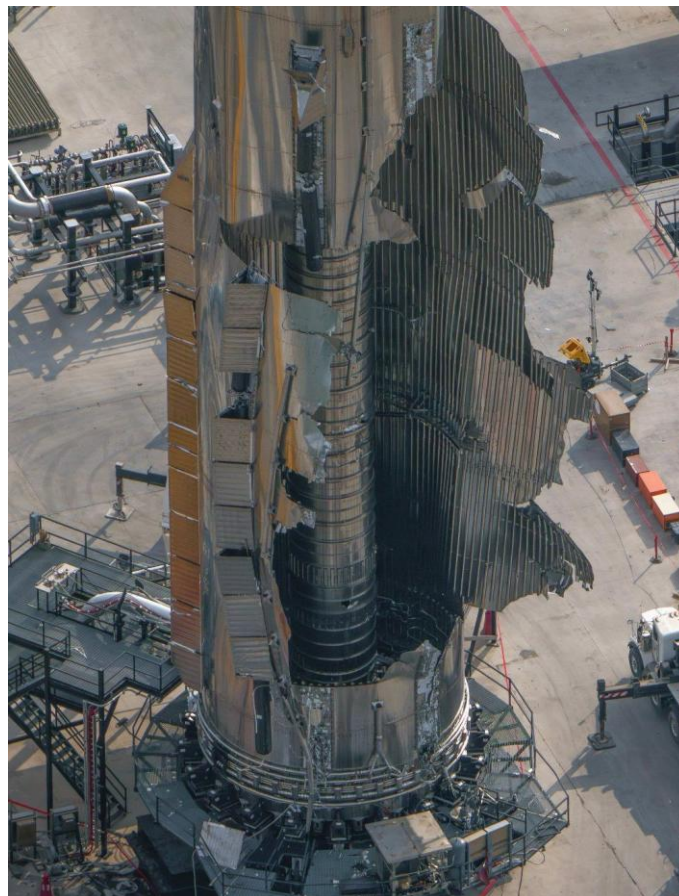
Fig. 1 – General view of internal components of SH18 (B18) booster – the first unit of new V3 version after unsuccessful cryogenic testing [7]

A comparison of diameters of central pipes for supplying methane to the engines of V3 and V1 versions of the booster (see Figures 1 and 2) reveals, at first glance, an inexplicable increase in its cross-section in the new version.

Comparing Figs. 1 and 2 reveals that the central methane supply pipe of V3 booster has increased in volume several times and has become absolutely enormous – its diameter is now almost the same as that of entire Falcon 9 rocket. This is hardly a merit, as it increases complexity and mass of the booster fuel system.

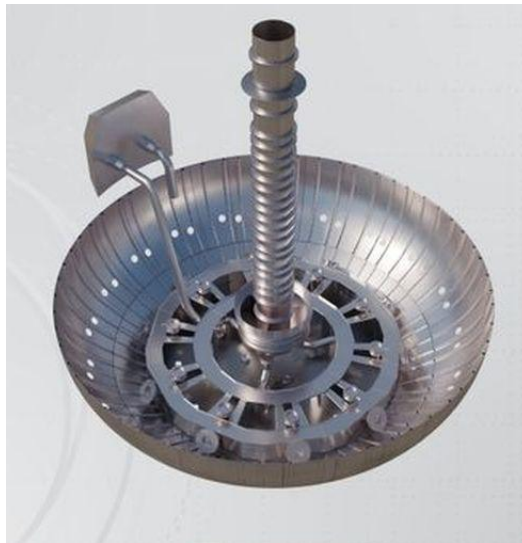
Fig. 2 – Render of oxygen tank lower part of SH7+ booster, version V1, with the lower section of central pipe for methane supply [8]

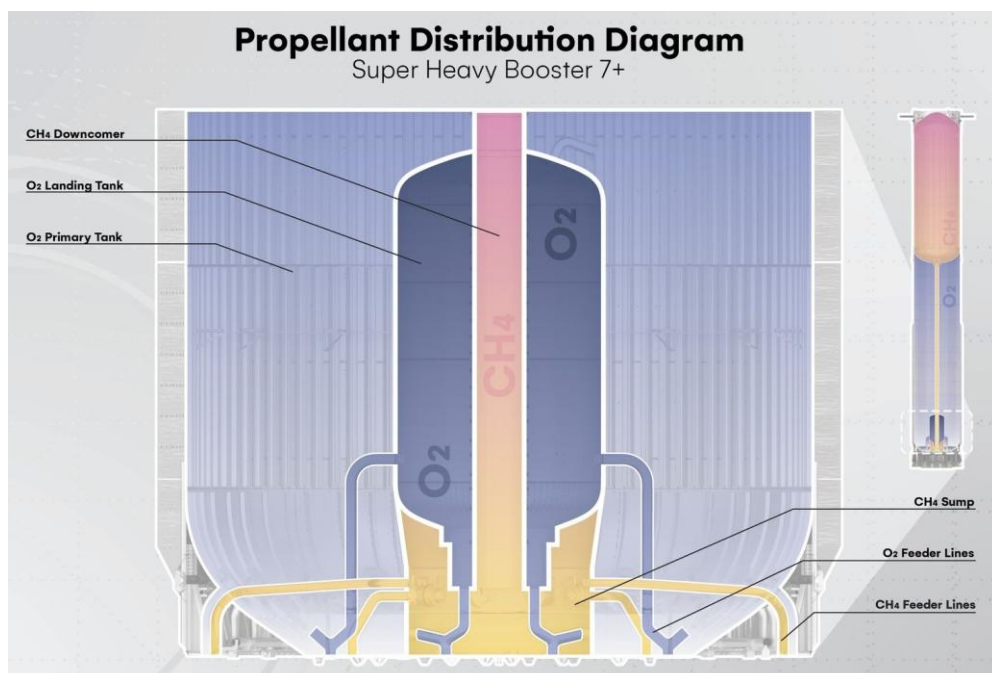
It is claimed that in this configuration, the central methane supply pipe to the booster engines, with its significantly increased cross-section, also serves as an intermediate header tank, and that this is a very successful solution [9]. However, it is quite obvious that by increasing the height of methane tank while correspondingly decreasing the height of oxygen tank, while maintaining its volume through a thinner central pipe with normal throughput, we would obtain a lighter structure. And all this has already been implemented in version V1 of the booster, see Fig. 3.

Fig. 3 – Schematic diagram of SH7+ booster, version V1, fuel distribution system [8]

The oxygen landing header tank, with its symmetrically arranged oxygen supply pipes, is well integrated around the relatively thin central methane supply pipe to the engines (see Fig. 3 and 4).

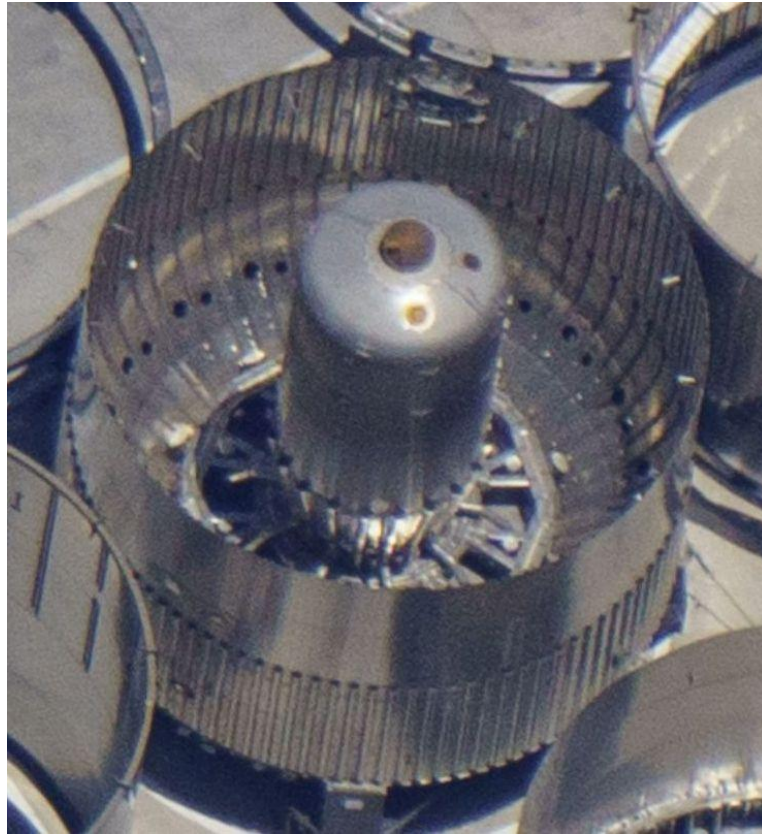
Fig. 4 – Lower part of SH7+ booster, version V1, main oxygen tank, with central landing oxygen tank [8]

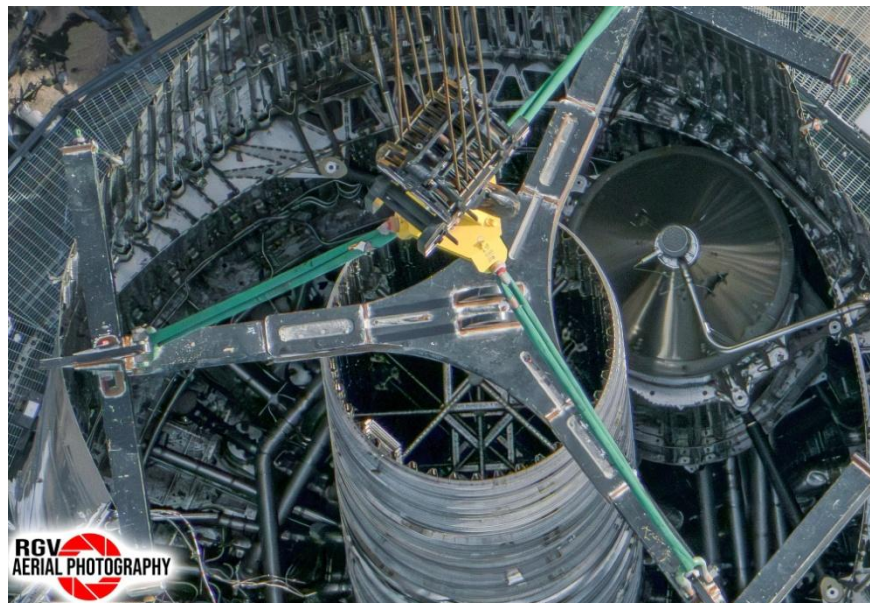
However, on new V3 version of booster, due to the enormous central pipe for supplying methane, it is no longer possible to place the oxygen landing tank in the center of main oxygen tank. Therefore, it is shifted to the side, distorting the previously symmetrical structure (see Fig. 5).

Fig. 5 – Lower part of SH18 booster, version V3, main oxygen tank with a side oxygen landing tank [9]

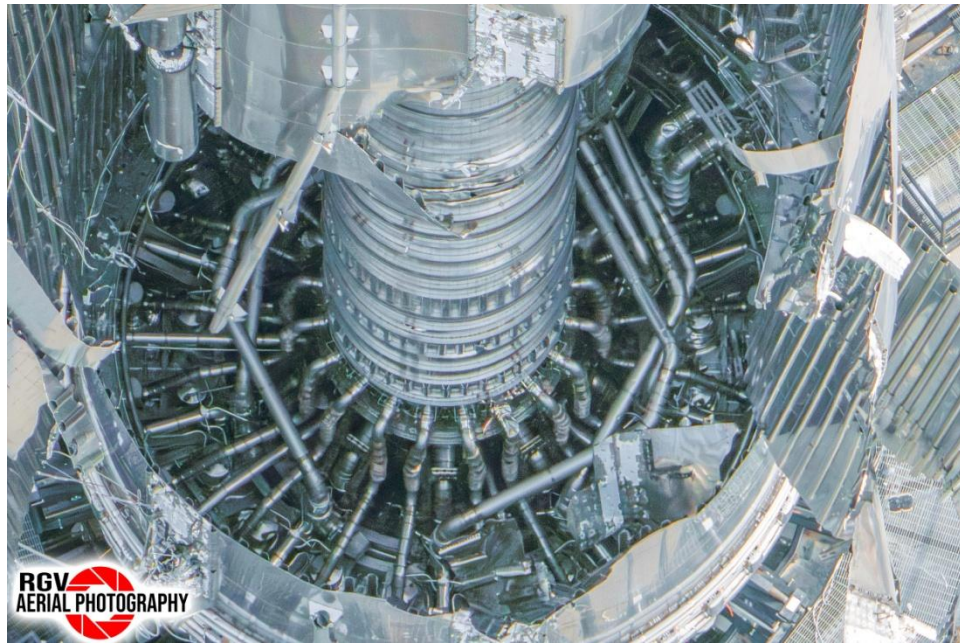
But worst of all, with this arrangement of the oxygen landing tank, 13 pipes supplying oxygen to 13 engines operating during landing will inevitably have at least 7 different lengths instead of the previous two (see Fig. 6). This means that there is a possibility of up to 7 different Pogo variants occurring, which may be simply impossible to resolve through flight testing. According to the chosen method for identifying Pogo, testing this single component alone could require up to 7 Starship flights with explosions near landing tower.

Fig. 6 – Visible part of pipelines running from the side oxygen landing tank to the engines of SH18 booster, version V3 [7]

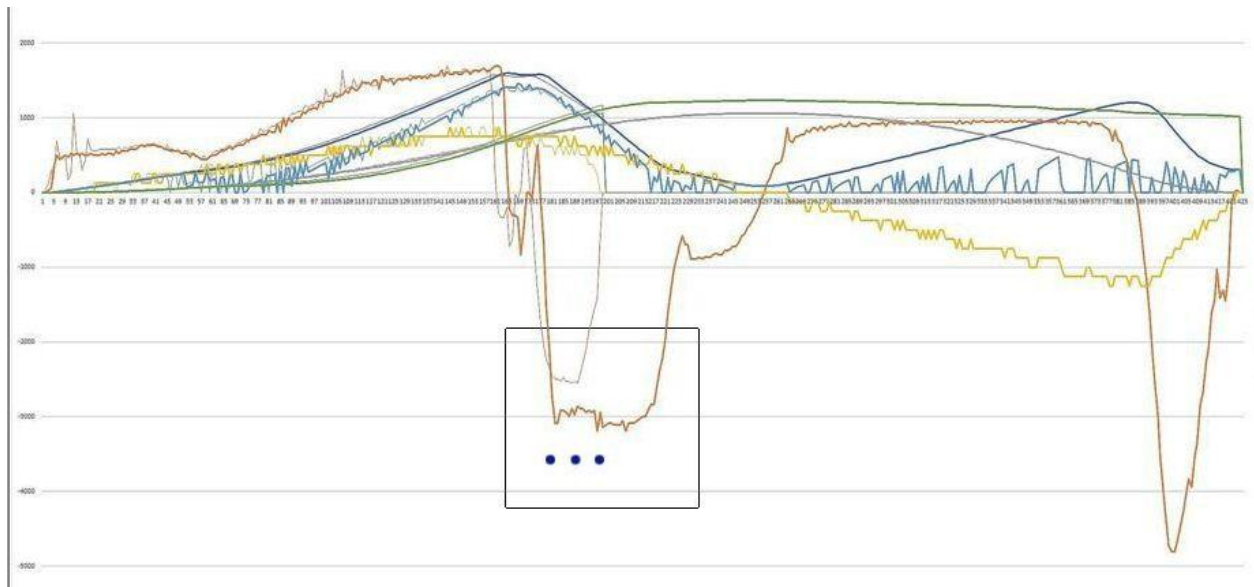
What caused such a clearly fuel distribution system unbalanced architecture of SH18 booster version V3 to emerge from the quite logical architecture of the previous version? Surprisingly, it was due to the fight against Pogo. The most dynamically complex maneuver performed by Starship booster is boostback – a 180° rotation around its transverse axis after hot staging, with 3 central engines operating and 10 inner-ring engines igniting during this rotation. The second flight demonstrated that it was precisely at this moment, with the initially chosen engine operating mode, that Pogo occurred on the booster, leading to explosion that shattered the booster into small pieces [6, 10]. Recalculating the frequency of hydroacoustic oscillations using a formula obtained by SpaceX from a Russian paper, and reducing engine thrust to exit "Pogo zone," allowed third flight to pass this phase of flight without an explosion (see Fig. 7).

Fig. 7 – Acceleration, velocity, altitude, and horizontal range, as well as the horizontal and vertical velocity components of Starship booster's during the second and third flights [6]

Comparing the accelerations of boosters in the second flight – 25 m/s^2 (thin gray line) and in the third flight – approximately 30 m/s^2 (thicker lilac line) during the quasi-stationary boostback phase, highlighted by rectangular frame in Fig. 7, and taking into account that in the second flight only 9 out of 13 engines were operating in this part of the trajectory, it is easy to see that in the third flight the thrust per engine was approximately 20 % lower than in the second. The calculated acceleration in the second flight with all engines operating should have been about 36 m/s^2 . This level is shown in Fig. 7 by three blue dots. This is the mode, unexpectedly for Starship system developers, turned out to be within Pogo excitation zone in the oxygen supply system to the inner ring engines of booster.

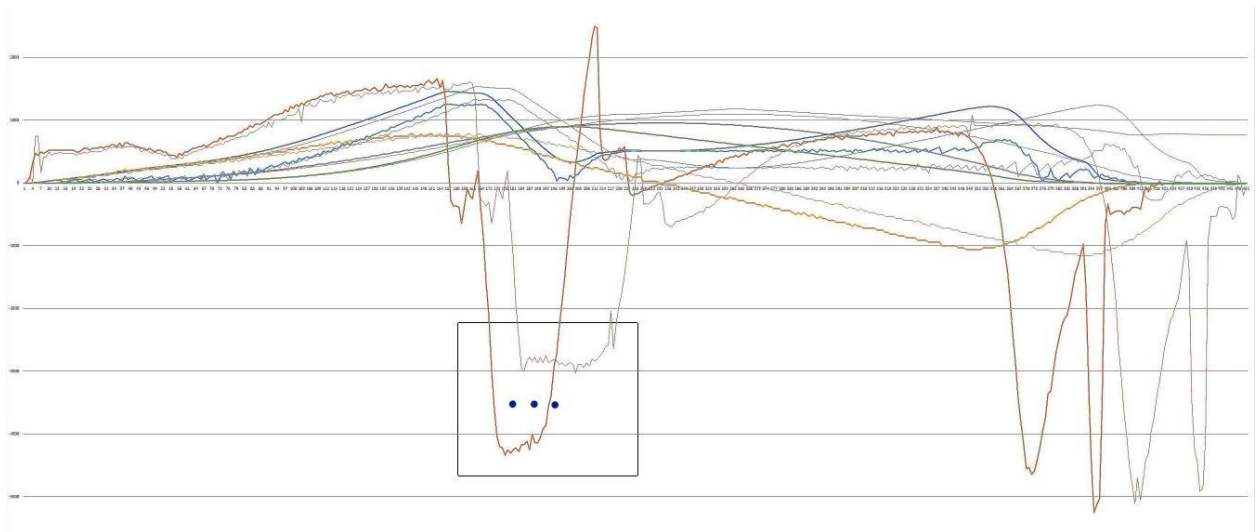
Booster explosion during the boostback of the third flight was avoided; however, the reduction in engine thrust proved insufficient, and auto-oscillations still occurred in the third flight, albeit in a relatively weak form, at the very end of this flight phase. This led to a deviation in final velocity vector position after engine shutdown and the booster following an unplanned trajectory [6]. In the subsequent, fourth flight, the engine thrust was reduced by another 3 %, so that maximum acceleration of the booster (thin gray line inside the rectangle) became approximately equal to 29 m/s^2 , see Fig. 8:

Fig. 8 – Acceleration, velocity, altitude, and horizontal range, as well as the horizontal and vertical velocity components of Starship booster's during the fourth and fifth flights [6]

This time everything went according to plan, and it was the first flight without explosions or major destruction, with both stages successfully performing a smooth splashdown, although the second stage was severely burned, even to the point of having holes in it. However, in the next flight, boostback was performed with a thrust level that exceeded the dangerous level by as much as it was below it in the fourth flight (acceleration increased from 29 to 43 m/s^2), see on Fig. 8 at thin gray and thick lilac lines inside the rectangle. The maneuver time was correspondingly reduced. And since then, the same accelerated boostback maneuver was always planned, at least this can be stated up to the eighth launch, after which the presentation of this data was discontinued.
