# The 13/33 engine exchange as a mirror of SpaceX's design approach

Yu. I. Lobanovsky

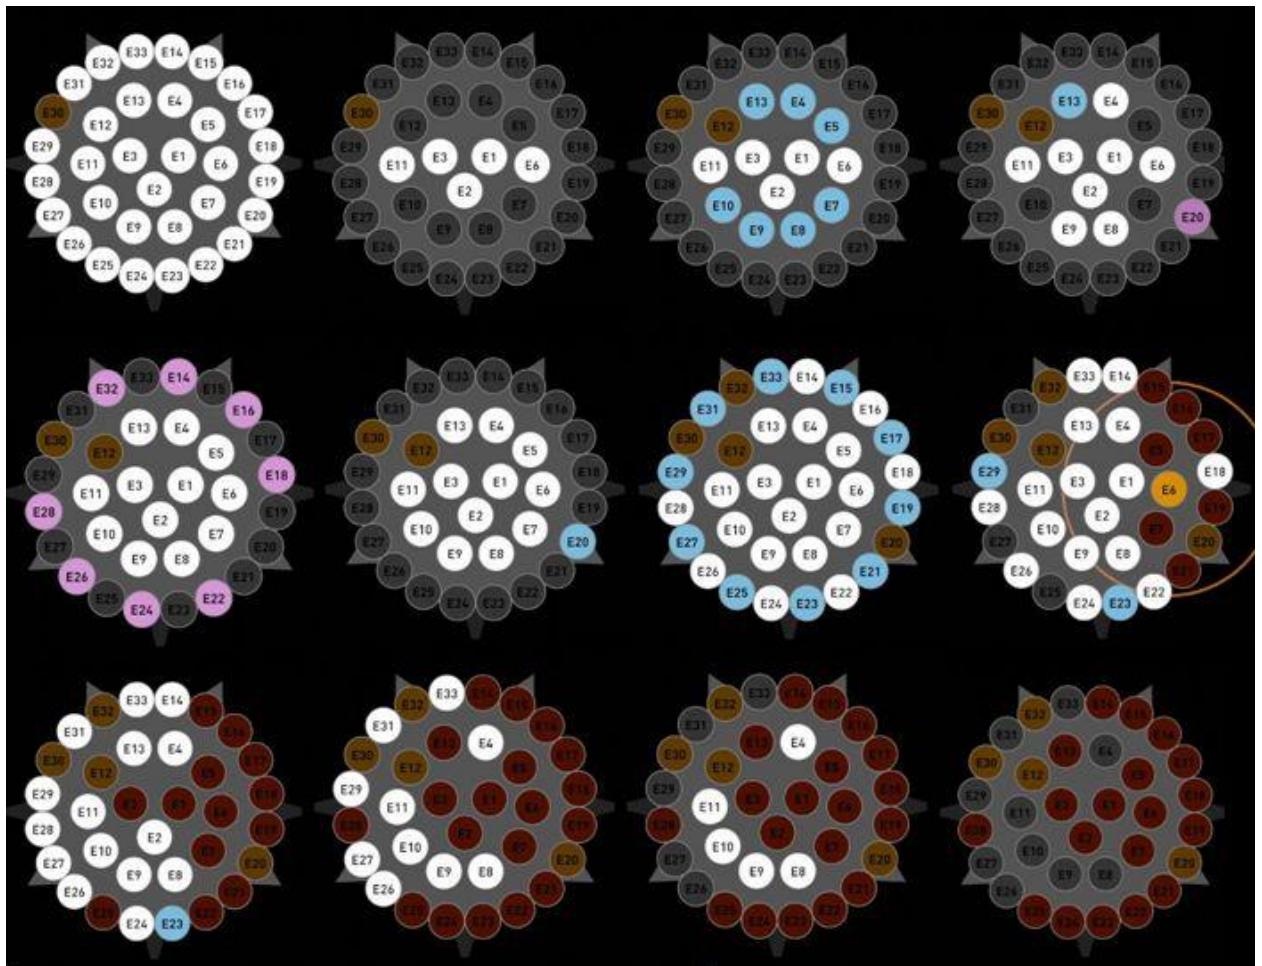
According to the engine operation visualization data, after the remaining inner ring engines began to ignite, they appeared to shut down again for a fraction of a second, but then all of them, except for engine E12, started operating more or less steadily. Following this, the outer ring engines (which was previously physically impossible) began to ignite in two symmetrical groups of 10 (staggered in an every-other-engine pattern), also in a somewhat unstable mode. At that moment, engine E6, which had been running continuously since liftoff, exploded, and several surrounding engines ceased operating almost immediately. A fraction of a second later, only 10 engines remained running, then 5 outer ring engines were shut down, leaving only 5 inner ring engines operating, which were capable of thrust vectoring. These were mostly the engines furthest from the explosion site, but soon they were also shut down. Nevertheless, they managed to stabilize the booster, which had begun to rotate rapidly and erratically due to thrust asymmetry, demonstrating the outstanding performance of its control system under severe accident conditions.

And, as the flight experiment demonstrated, the engine restart failed [1]. Fig. 1 shows 12 sequential images of the propulsion system's status at that moment from source [16], which utilized images from the engines status screen on video [1] slowed down by a factor of 4. Here, the white circles represent operating engines, dark gray indicates shut-down engines, light blue represents igniting engines, purple indicates shutting-down engines, light brown represents engines that lost thrust and control prior to the explosion of engine E6, and dark brown – after its explosion. The light chocolate color of engine E6 and the circle of the same color around it in the far-right image of the middle row in Fig. 1 indicate its explosion and the propagation zone of its explosive shockwave at that moment. Although these images represent the real changes in the propulsion system's status at the moment of the attempted boostback maneuver only to a fairly low degree, even they show how chaotically the engines reacted to the highly explicit startup sequence described at the beginning of the article. And yet, it seemed as though it was almost successfully executed – with the exception of three engines that joined the outer ring engine E30, which had been completely shut down long before, the remaining 29 engines were either already operating in the minimum mode or were igniting (see the right-center image in the middle row). However, at that moment, the inner ring engine E6, which had been running continuously since liftoff, exploded, and the shockwave from it extinguished all engines except for ten (see the left-center image in the bottom row). Immediately following this, all five remaining fixed-thrust outer ring engines were shut down so that they don't interfere with the stabilization of the booster using the five vectoring engines of the inner ring.

**Fig. 1 – 12 sequential images of the booster propulsion system's status during the attempted boostback maneuver**

4. However, the lower operating stability of the rocket engines at the boundary of allowable operating modes led to their multiple failures and even the explosion of one of the engines upon ignition during the highly dynamically complex phase of initiating the boostback – the turnaround of the booster for flight in the opposite direction.
